**Flood Control Project Maintenance
Levee Inspections**

Maintenance Issue Types Only, Levee Inspection Report By Mile - Spring 2016

Reclamation District No. 2062 Stewart

Waterway	Bank	Unit Miles	Inspection Start/End	Inspector
Unit No. 01 San Joaquin River	Left	2.64	04/20/2016 04/20/2016	Maksim Khashchuk

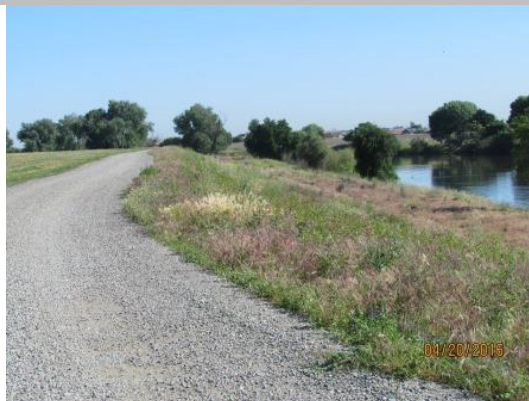
Photo 1 of 1 : SP_2016_RD2062_309_7_20160421_00011.jpg

LM Start	0.00	Rating **	M	Issue No.	7
LM End	2.47	Issue Type +	Ma	Location *	WS
Category	Earthen Levee			GPS Latitude/Longitude	
				Start	End
Item	Vegetation			37.807450 °	37.789392 °
				-121.328023 °	-121.308986 °
DWR ID	DWR_RD2062_01_s_2016_7				
Comment Code					
V1 : Control annual grass and weeds on the levee slopes and easements.					
Inspector Comment

View of the vegetation on the waterside levee slope.

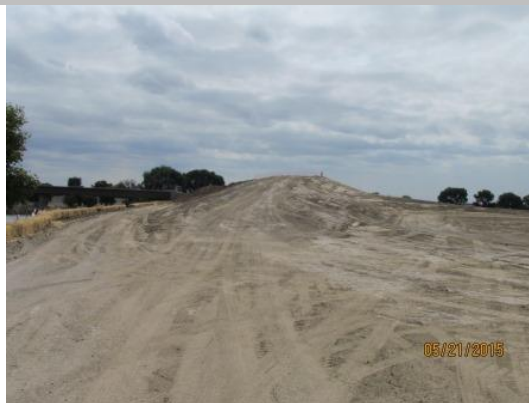
Photo 1 of 1 : SP_2016_RD2062_309_6_20160229_00001.jpg

LM Start	0.72	Rating **	A/W	Issue No.	6
LM End	0.72	Issue Type +	Ma	Location *	WS
Category	Earthen Levee			GPS Latitude/Longitude	
				Start	End
Item	Crown Surface / Depressions / Rutting			37.805138 °	37.805138 °
				-121.316420 °	-121.316420 °
DWR ID	DWR_RD2062_01_s_2015_6				
Comment Code					
C3 : Add appropriate gravel or road base. Grade and compact.					
Inspector Comment					
New levee patrol road is being installed. Make sure all-weather access is available before next flood season.

View of the new patrol road installation in process.

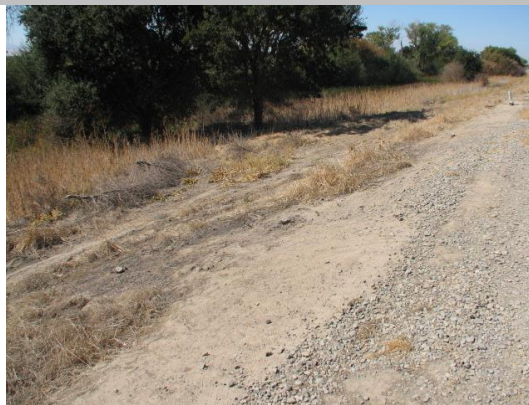
Photo 1 of 1 : SP_2016_RD2062_310_3_20160229_00001.jpg

Three small stumps on levee slope.

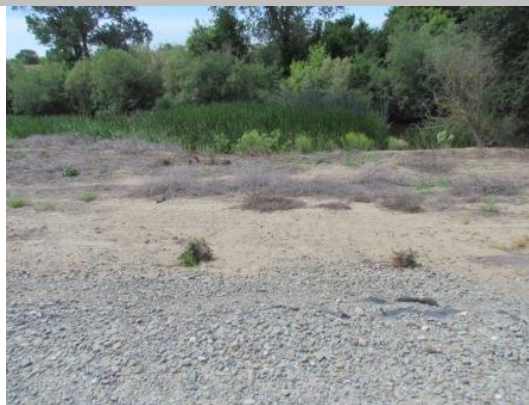
Photo 1 of 1 : SP_2016_RD2062_310_13_20160229_00003.jpg

LM Start	2.88	Rating **	N	Issue No.	13
LM End	2.88	Issue Type +	Ma	Location *	WS
Category	Earthen Levee			GPS Latitude/Longitude	
				Start	End
Item	Trim / Thin Trees			37.804060 °	37.804060 °
				-121.373245 °	-121.373245 °
DWR ID	DWR_RD2062_02_s _ 2012_13				
Comment Code					
T5 : Tree stumps.					
Inspector Comment					
Four small oak stumps on levee slope.

View of tree stumps on waterside slope. 05/17/2012

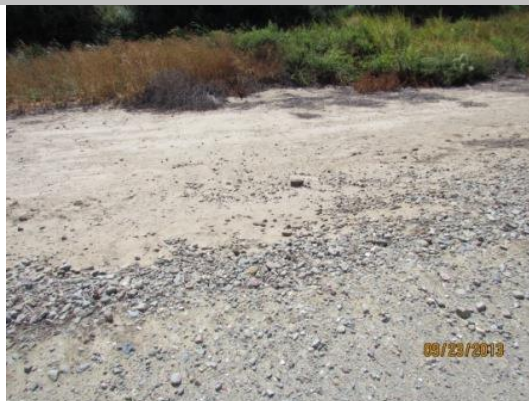
Photo 1 of 1 : SP_2016_RD2062_310_14_20160229_00004.jpg

View of the tree stump in the middle of the photo.

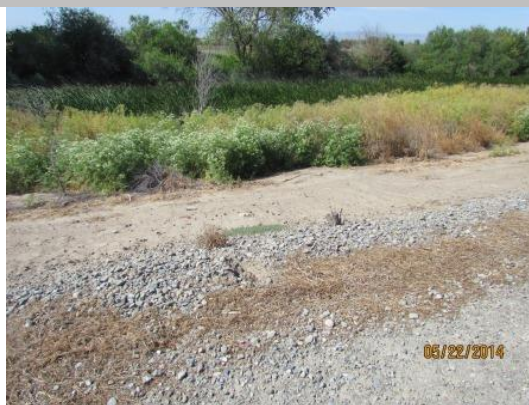
Photo 1 of 1 : SP_2016_RD2062_310_15_20160229_00005.jpg

LM Start	3.01	Rating **	N	Issue No.	15
LM End	3.01	Issue Type +	Ma	Location *	WS
Category	Earthen Levee			GPS Latitude/Longitude	
				Start	End
Item	Trim / Thin Trees			37.804481 °	37.804481 °
				-121.375510 °	-121.375510 °
DWR ID	DWR_RD2062_02_s_2012_15				
Comment Code					
T5 : Tree stumps.					
Inspector Comment

View of the tree stumps on the waterside levee slope.

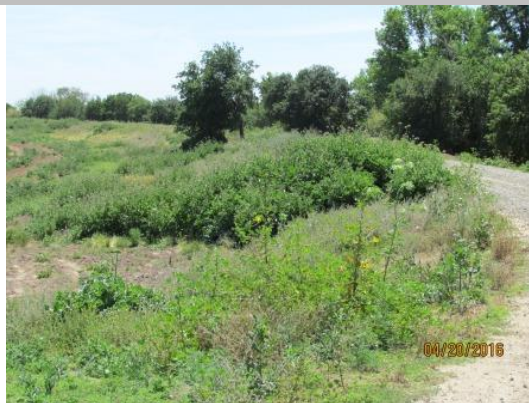
Photo 1 of 1 : SP_2016_RD2062_310_11_20160421_00030.jpg

View of the vegetation on the landside levee slope.

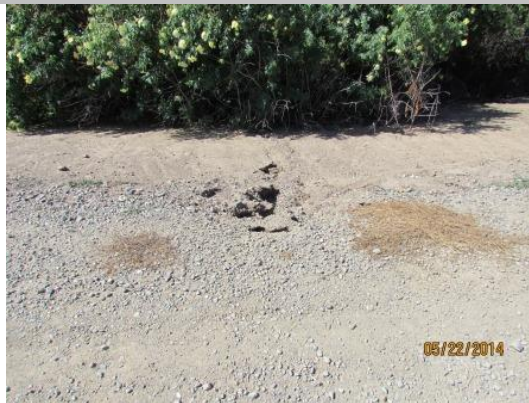
Photo 1 of 1 : SP_2016_RD2062_310_8_20160229_00002.jpg

LM Start	3.64	Rating **	M	Issue No.	8
LM End	3.64	Issue Type +	Ma	Location *	WS
Category	Earthen Levee			GPS Latitude/Longitude	
				Start	End
Item	Erosion / Bank Caving			37.806347 °	37.806347 °
				-121.386692 °	-121.386692 °
DWR ID	DWR_RD2062_02_s_2014_8				
Comment Code					
E2 : Schedule repair of erosion site prior to the next inspection.					
Inspector Comment

View of the erosion from surface runoff on the waterside levee slope.

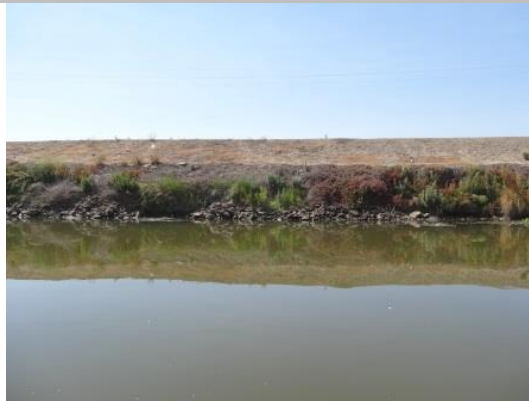
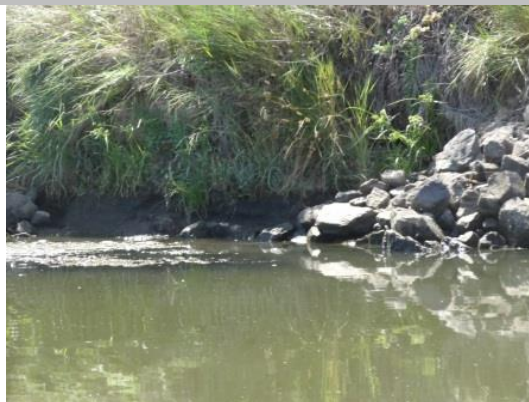
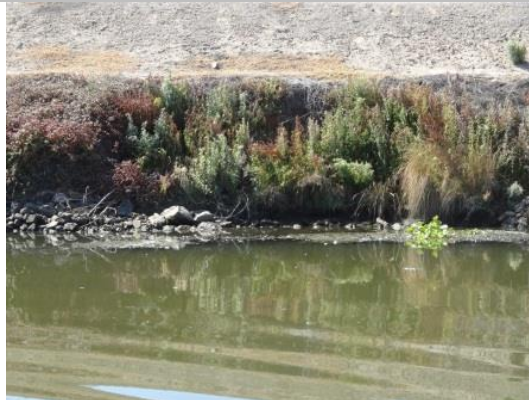
LM Start	0.00	Rating **	U	Issue No.	8
LM End	0.09	Issue Type +	Ma	Location *	WS
Category	Supplemental			GPS Latitude/Longitude	
				Start	End
Item	DWR Erosion Survey			37.809673 °	37.809673 °
				-121.390321 °	-121.390321 °
DWR ID	DWR_RD2062_03_s_2016_8				
Comment Code					
Inspector Comment					
06/25/2015: No significant change observed.					
07/02/2014: No significant change observed.					
08/13/2013: No significant change observed.					
08/07/2012: The site has been visited by boat survey. No significant change observed					
08/23/2011: Site is at the upstream of a drainage ditch. [2015 Site ID:RD2062U03RM29.93]

Front view of the erosion.

Close view of the erosion.

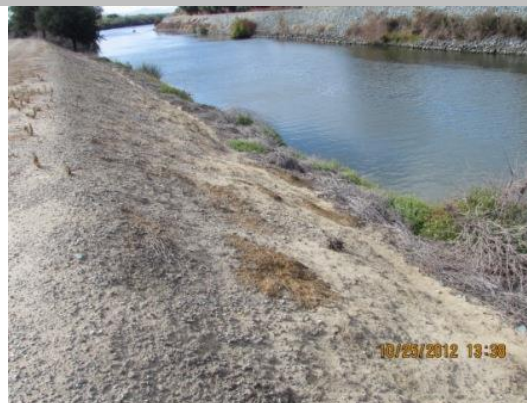
Photo 1 of 1 : SP_2016_RD2062_311_3_20160229_00006.jpg

View of tree stumps on waterside slope.

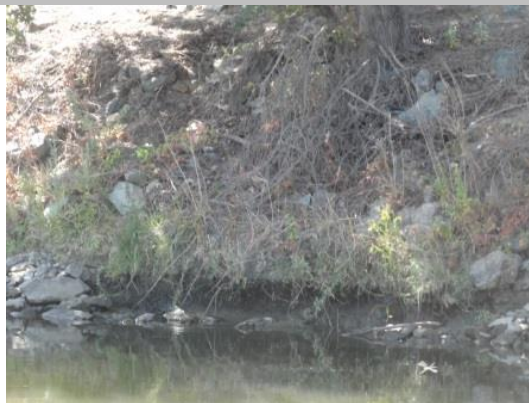
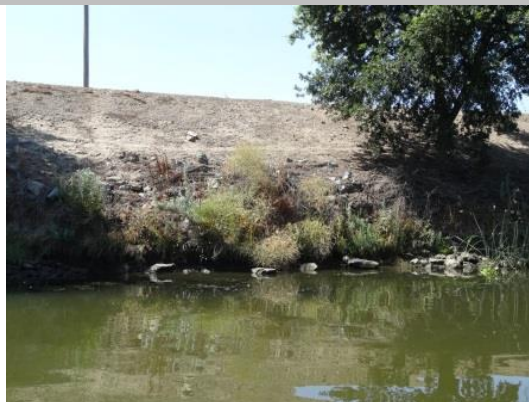
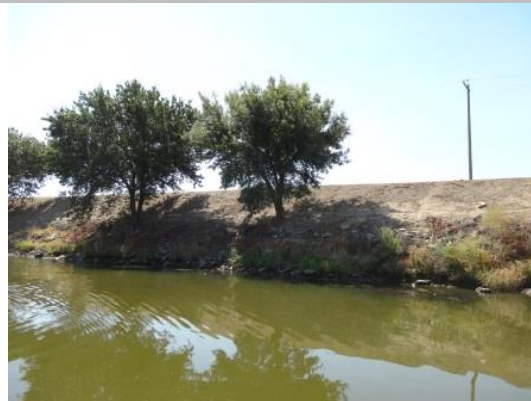
LM Start	0.10	Rating **	U	Issue No.	9	
LM End	0.11	Issue Type +	Ma	Location *	WS	
Category	Supplemental			GPS Latitude/Longitude		
				Start	End	
Item	DWR Erosion Survey			37.810052 °	37.810052 °	
				-121.388847 °	-121.388847 °	
DWR ID	DWR_RD2062_03_s_2016_9					
Comment Code						
Inspector Comment						
06/25/2015: No significant change observed.						
07/02/2014: No significant change observed.						
08/13/2013: No significant change observed.						
08/07/2012: The site has been visited by boat survey. No significant change observed						
08/23/2011: Hard to view the erosion because of the dense vegetation and trees on site. The site is under the bush, close to the tree. [2015 Site ID:RD2062U03RM30.02]

Close view of the site. Note the vegetation.

Front view of the site.

View of the site from downstream.

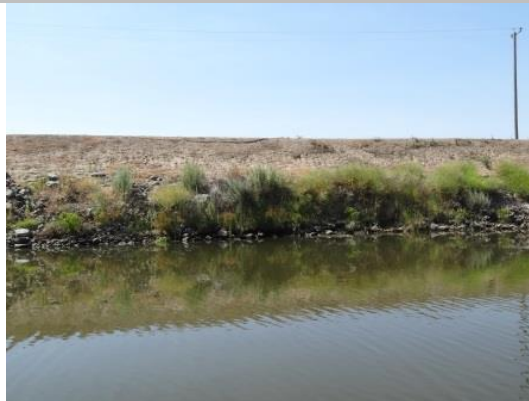
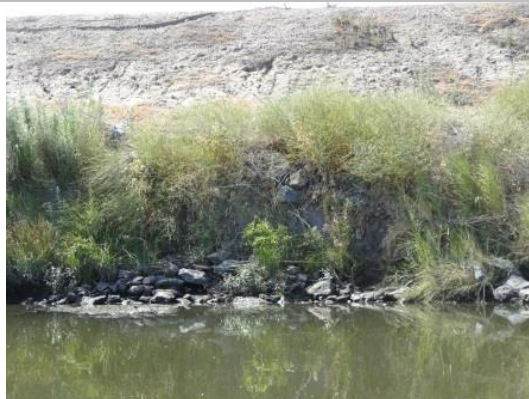
LM Start	0.18	Rating **	M	Issue No.	13
LM End	0.18	Issue Type +	Ma	Location *	WS
Category	Supplemental			GPS Latitude/Longitude	
				Start	End
Item	DWR Erosion Survey			37.810468 °	37.810468 °
				-121.387492 °	-121.387492 °
DWR ID	DWR_RD2062_03_s_2016_13				
Comment Code					
Inspector Comment					
06/25/2015: No significant change observed.					
07/02/2014: No significant change observed.					
08/13/2013: No significant change observed.					
08/07/2012: The site has been visited by boat survey. No significant change observed					
08/23/2011: The protection at the levee toe has been washed away.					
[2015 Site ID:RD2062U03RM30.1]

Direct view of the site.

Close view of the erosion.

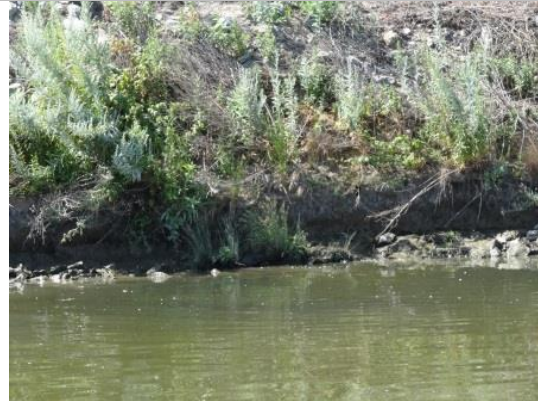
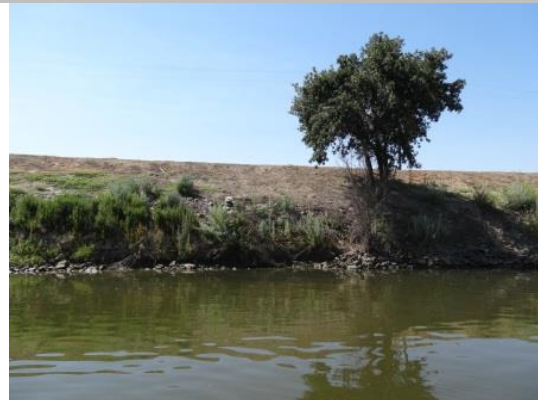
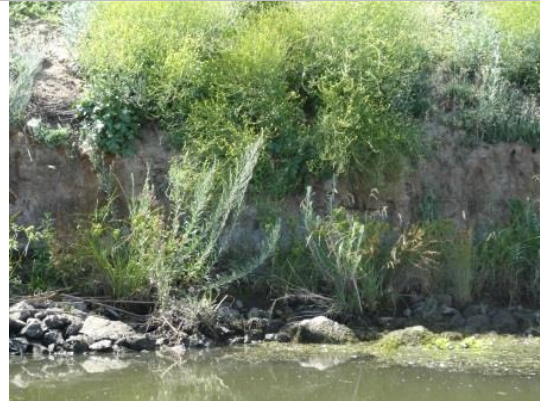
06/25/2015: No significant change observed.
 07/02/2014: No significant change observed.
 08/13/2013: A new pocket erosion at the upper levee slope has been found directly above a large tree. The erosion might have been caused by internal pipe leakage or surface runoff.
 08/07/2012: The site has been visited by boat survey. No significant change observed
 08/23/2011: No significant change observed on site. Dense vegetation is visible along the water line.
 09/07/2010: No significant change observed on site. Much of the upper slope was recently cleared of vegetation by spraying. 4- to 6-foot vertical scarp and pocket erosions are lined along a span of 475 feet. In some sections, the vertical scarp encroaches into the levee prism. There is a lack of berm along this reach, exposing the levee slope to high flow velocities during normal and flood events.
 08/06/2010: Recommended as local maintenance issue, per CLRO.

03/09/2010: As discussed with Michael Moncrief of MBK Engineers, the site will be 'addressed' later this year.
 09/29/2009: No major change observed since last visit; pocket erosion and a vertical scarp forming; this site was combined with Site RM30.13 and 30.02 with a combined total erosion length of 475 feet; recommended as annual assessment and monitoring of the site, per CLRO CES Evaluation 2008 Report; previously rated "M".
 11/05/2008: Top of vertical scarp has rip rap that appears to be sliding; rodent holes; existing toe rip rap. [2015 Site ID:RD2062U03RM30.19]

Front view of the existing erosion at the toe.

View of the pocket erosion and the tree.

Close view of the pocket erosion.

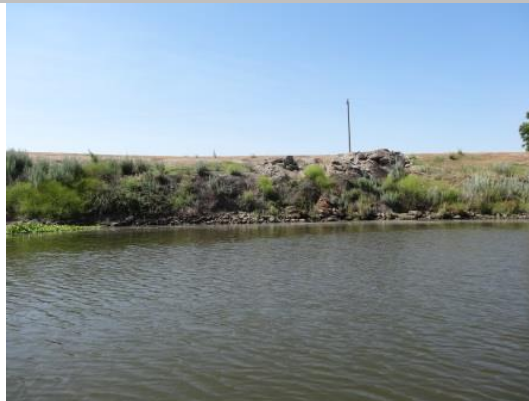
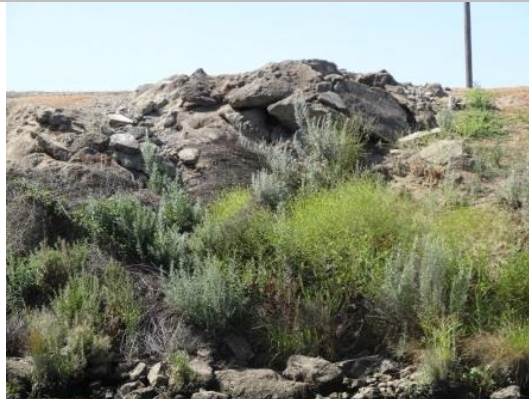
LM Start	0.35	Rating **	M	Issue No.	1
LM End	0.35	Issue Type +	Ma	Location *	WS
Category	Supplemental			GPS Latitude/Longitude	
				Start	End
Item	DWR Erosion Survey			37.811281 °	37.811281 °
				-121.384461 °	-121.384461 °
DWR ID	DWR_RD2062_03_s_2016_1				
Comment Code					
Inspector Comment					
06/25/2015: No significant change observed.					
07/02/2014: No significant change observed.					
08/13/2013: No significant change observed.					
08/07/2012: The site has been visited by boat survey. No significant change observed					
08/23/2011: The site is right at the downstream of a river bend. [2015 Site ID:RD2062U03RM30.27]

Front view of the erosion.

Close view of the site. Note the piled concrete debris.

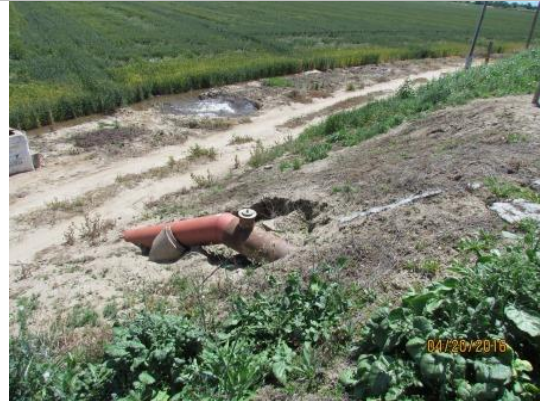
Photo 1 of 1 : SP_2016_RD2062_311_38_20160421_00053.jpg

LM Start	0.51	Rating **	M	Issue No.	38
LM End	0.51	Issue Type +	Ma	Location *	LS
Category	Earthen Levee			GPS Latitude/Longitude	
				Start	End
Item	Erosion / Bank Caving			37.812552 °	37.812552 °
				-121.382781 °	-121.382781 °
DWR ID	DWR_RD2062_03_s_2016_38				
Comment Code					
E2 : Schedule repair of erosion site prior to the next inspection.					
Inspector Comment

View of the landside levee slope erosion around the pipe.

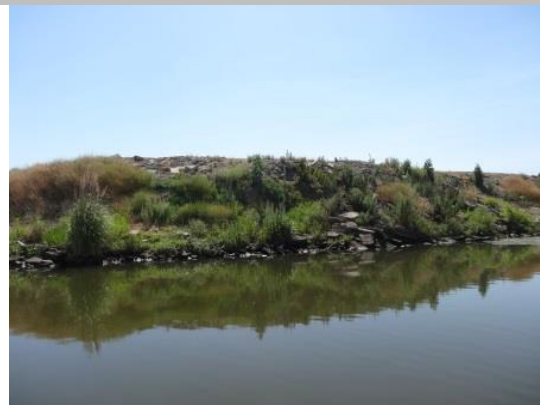
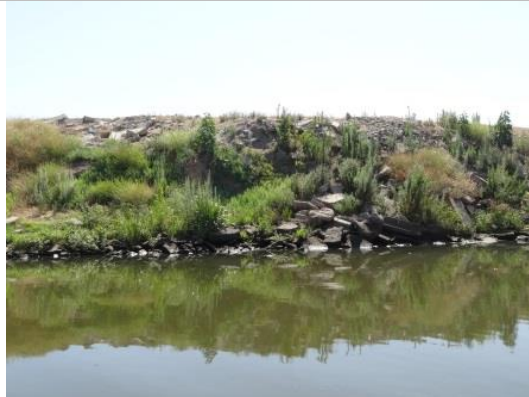
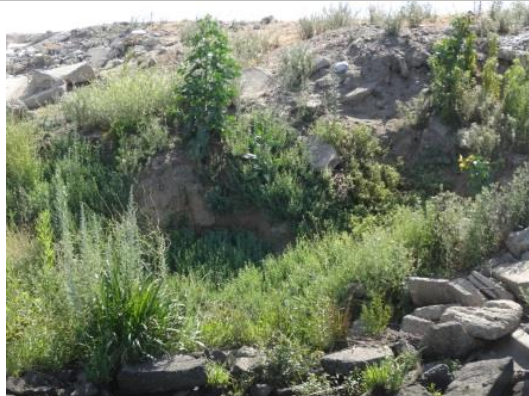
LM Start	0.55	Rating **	M	Issue No.	2
LM End	0.56	Issue Type +	Ma	Location *	WS
Category	Supplemental			GPS Latitude/Longitude	
				Start	End
Item	DWR Erosion Survey			37.813070 °	37.813070 °
				-121.383100 °	-121.383100 °
DWR ID	DWR_RD2062_03_s_2016_2

Comment Code					
Inspector Comment					
06/25/2015: No significant change observed.					
07/02/2014: No significant change observed.					
08/13/2013: No significant change observed.					
08/07/2012: The site has been visited by boat survey. No significant change observed.					
08/23/2011: No significant change observed on site.					
09/07/2010: No significant change observed on site. Much of the placed rip rap revetment has slid. It is no longer adequately protecting the slope.					
08/06/2010: Recommended as local maintenance issue, per CLRO Report.					
03/09/2010: As discussed with Michael Moncrief of MBK, site will be 'addressed' this year.					
09/29/2009: No major change observed since last visit; a section of the rip rap has slipped, exposing a levee section that has eroded; recommended as local maintenance issue, per CLRO CES Evaluation 2008 Report; Site # is the same as RM30.43,LM0.63; previously rated "U".

Front view of the site.

Front view of the site. Previously placed rip rap slipped, exposing the underlying soils and creating a pocket.

Front view of the site. Rip rap no longer adequately protecting levee slope.

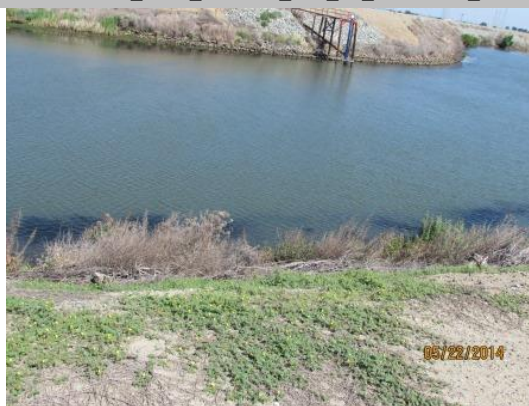
Photo 1 of 1 : SP_2016_RD2062_311_12_20160229_00022.jpg

LM Start	0.64	Rating **	N	Issue No.	12
LM End	0.64	Issue Type +	Ma	Location *	WS
Category	Earthen Levee			GPS Latitude/Longitude	
				Start	End
Item	Trim / Thin Trees			37.813894 °	37.813894 °
				-121.381680 °	-121.381680 °
DWR ID	DWR_RD2062_03_s_2012_12				
Comment Code					
T5 : Tree stumps.					
Inspector Comment					
2 stumps on waterside slope.

View of the tree stumps on the waterside levee slope.

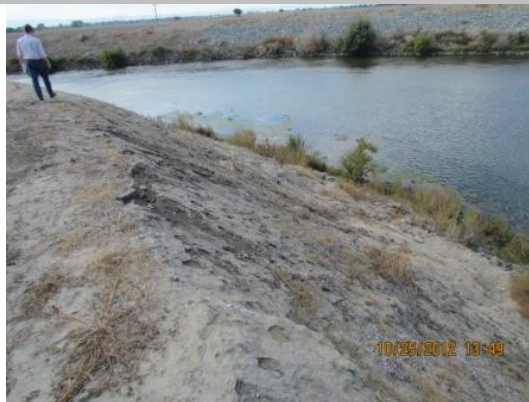
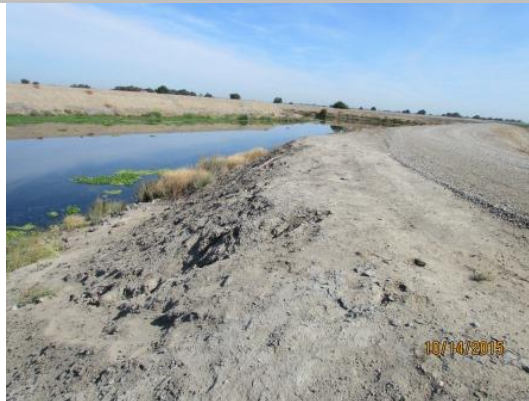
LM Start	0.81	Rating **	A/W	Issue No.	11
LM End	0.81	Issue Type +	Ma	Location *	WS
Category	Earthen Levee			GPS Latitude/Longitude	
				Start	End
Item	Erosion / Bank Caving			37.816315 °	37.816315 °
				-121.381587 °	-121.381587 °
DWR ID	DWR_RD2062_03_s_2012_11				
Comment Code					
E2 : Schedule repair of erosion site prior to the next inspection.					
Inspector Comment					
Cracking developing along the waterside levee hinge.

View of slope erosion from foot traffic.

View of cracking at waterside levee hinge.

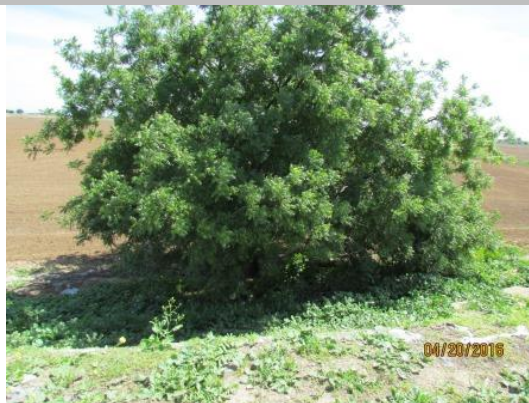
Photo 1 of 1 : SP_2016_RD2062_311_36_20160421_00054.jpg

LM Start	1.04	Rating **	M	Issue No.	36
LM End	1.04	Issue Type +	Ma	Location *	LS
Category	Earthen Levee			GPS Latitude/Longitude	
				Start	End
Item	Trim / Thin Trees			37.817764 °	37.817764 °
				-121.378623 °	-121.378623 °
DWR ID	DWR_RD2062_03_s_2016_36				
Comment Code					
T1 : Trim trees to at least five feet above ground level.					
Inspector Comment

View of the tree at the landside levee toe.

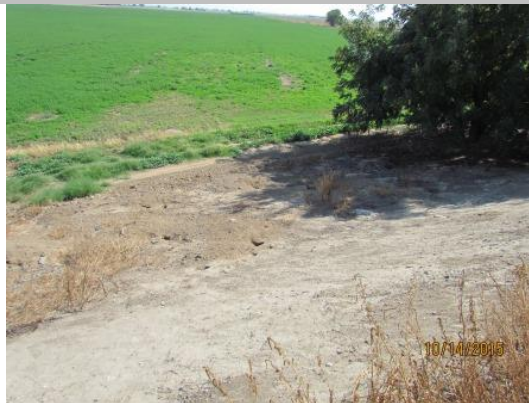
Photo 1 of 1 : SP_2016_RD2062_311_34_20160229_00033.jpg

LM Start	1.05	Rating **	A/W	Issue No.	34
LM End	1.05	Issue Type +	Ma	Location *	LS
Category	Earthen Levee			GPS Latitude/Longitude	
				Start	End
Item	Animal Control			37.817897 °	37.817897 °
				-121.378649 °	-121.378649 °
DWR ID	DWR_RD2062_03_f_2015_34				
Comment Code					
A1 : Exterminate rodents and backfill and compact or grout burrows.					
Inspector Comment					
LMA grouted rodent burrows.

View of the rodent burrows at the landside levee toe.

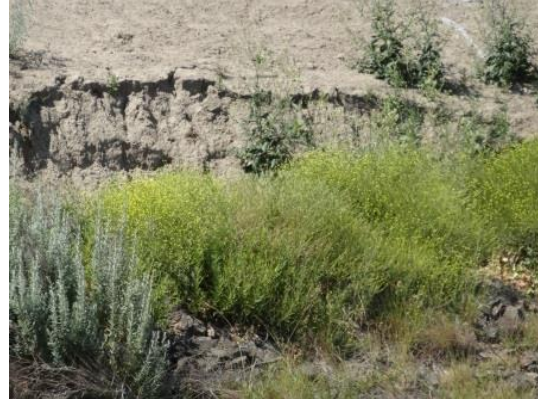
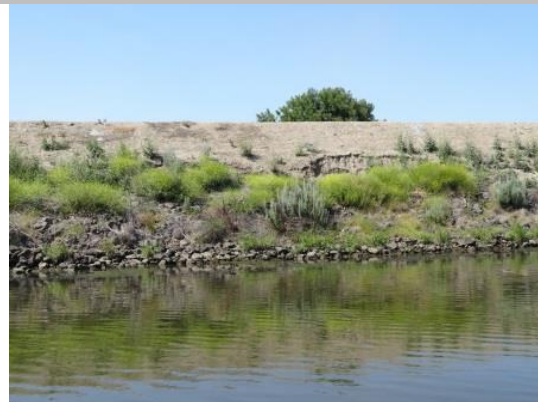
06/25/2015: No significant change observed.
 07/02/2014: No significant change observed.
 08/13/2013: No significant change observed.
 08/07/2012: The site has been visited by boat survey. No significant change observed
 08/23/2011: No significant change observed on site.
 09/07/2010: No significant change observed on site. Much of the seasonal grass along the slope was cleared. Site consists of an existing scalloped erosion approximately 30 feet long by 5 feet wide at its widest opening. The lateral crack is extended outwards along the middle slope. There is a 1 to 2 feet of differential settlement that could further develop into a shallow slide.
 08/06/2010: Recommended as local maintenance issue, per CLRO.
 03/09/2010: As discussed with Michael Moncrief of MBK Engineer, site will be 'addressed' this year.
 09/28/2009: No major change observed; section of rip rap has slipped, creating a terraced effect; dense vegetation growth; recommended as a local maintenance issue, per CLRO CES Evaluation 2008 Report; Site # is the same as RM31.12,LM1.25; previously rated "U".

Close view of the site.

Front view of the site.

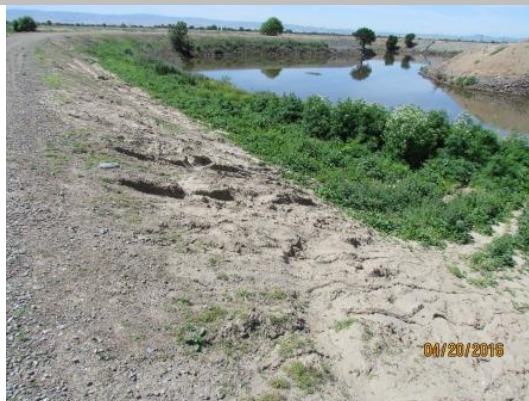
Photo 1 of 1 : SP_2016_RD2062_311_32_20160421_00052.jpg

LM Start	1.31	Rating **	M	Issue No.	32
LM End	1.31	Issue Type +	Ma	Location *	WS
Category	Earthen Levee			GPS Latitude/Longitude	
				Start	End
Item	Slope Stability			37.820390 °	37.820390 °
				-121.377148 °	-121.377148 °
DWR ID	DWR_RD2062_03_s_2016_32				
Comment Code					
S3 : Repair the levee slope damaged by vehicle traffic and prevent access where possible.					
Inspector Comment

View of the tire tracks on the waterside levee slope.

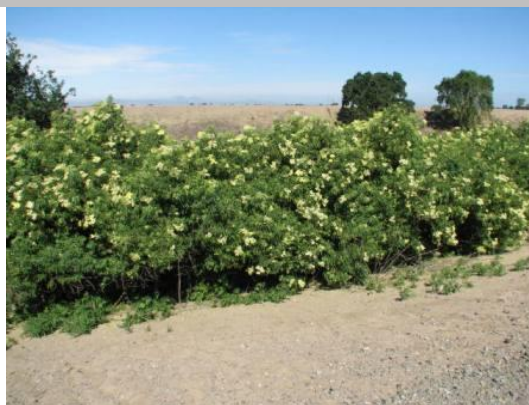
Photo 1 of 1 : SP_2016_RD2062_311_18_20160229_00029.jpg

LM Start	1.35	Rating **	A/W	Issue No.	18
LM End	1.35	Issue Type +	Ma	Location *	WS
Category	Earthen Levee			GPS Latitude/Longitude	
				Start	End
Item	Vegetation			37.820885 °	37.820885 °
				-121.376986 °	-121.376986 °
DWR ID	DWR_RD2062_03_s_2012_18				
Comment Code					
V4 : Elderberries are blocking visibility and flood fight capability.					
Inspector Comment					
Elderberry bush blocks visibility.

05/11/2011 Elderberry bush on water side slope.

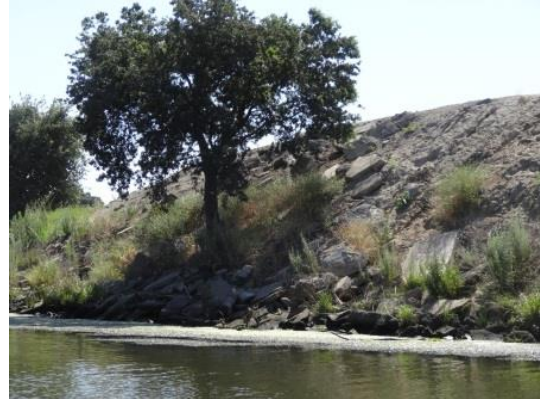
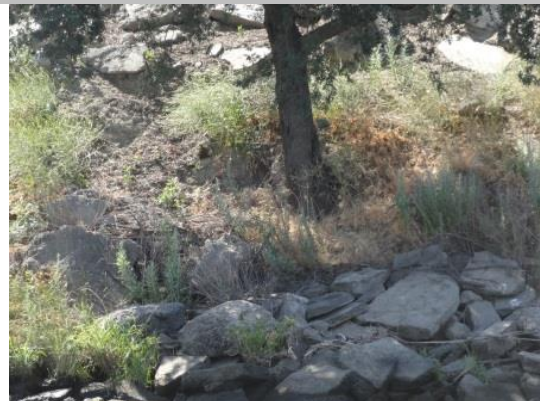
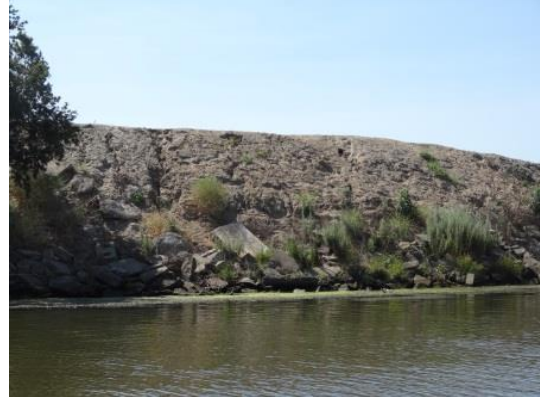
06/25/2015: No significant change observed.
 07/02/2014: No significant change observed.
 08/13/2013: No significant change observed.
 08/07/2012: The site has been visited by boat survey. No significant change observed
 08/23/2011: No significant change observed on site.
 09/07/2010: No significant change observed on site. There is a small- to medium sized Oak tree on the mid-slope just above rip rap. Some of the rip rap has collapsed, creating a pocket erosion just above the existing toe rip rap and upstream of the Oak tree.
 08/06/2010: Recommended as local maintenance issue, per CLRO.
 03/09/2010: As discussed with Michael Moncrief of MBK Engineer, site will be 'addressed' in 2010.
 09/29/2009: No major change since last visit; sliding of the rip rap at the base of the lone tree; there is noticeable man-made trail and foot traffic extending from the crown to the toe; much of the broken concrete used as temporary rip rap has slid, exposing portion of the bare levee slope; recommended as local maintenance issue, per CLRO CES Evaluation 2008 Report; Site # is the same as RM31.3, LM1.45; previously rated "M".

Front view of the site. Note existing broken concrete on the upper slope as well as on the lower slope and at the toe.

A closer view of the site.

Front view of the site.

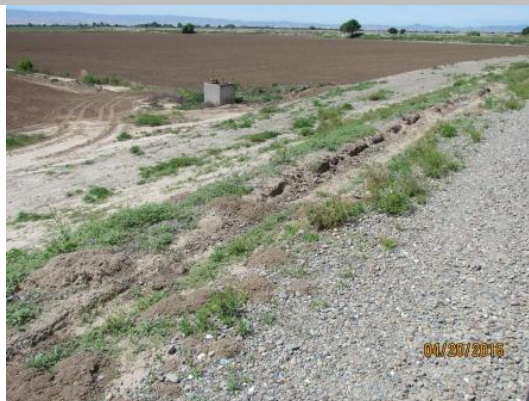
Photo 1 of 1 : SP_2016_RD2062_311_29_20160421_00051.jpg

View of a tire rut on the landside levee hinge.

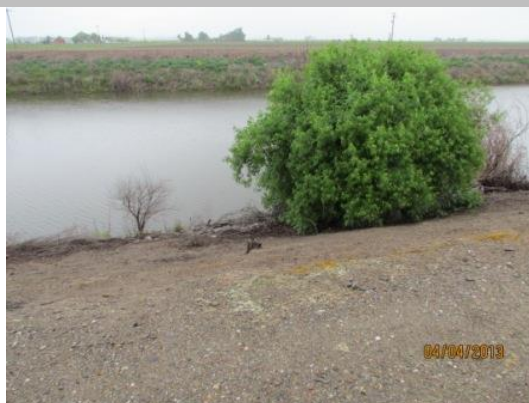
Photo 1 of 1 : SP_2016_RD2062_311_15_20160229_00025.jpg

View of the tree stump on the waterside levee slope.

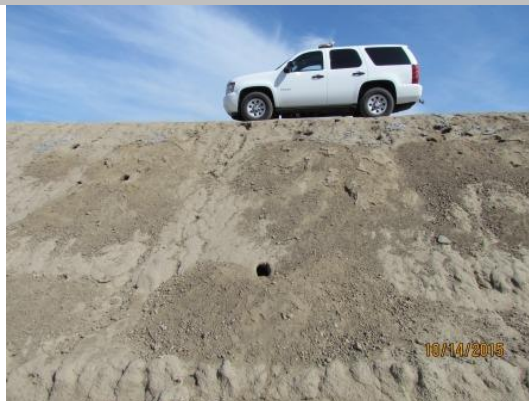
Photo 1 of 1 : SP_2016_RD2062_311_30_20160229_00031.jpg

View of the rodent hole on the landside levee slope.

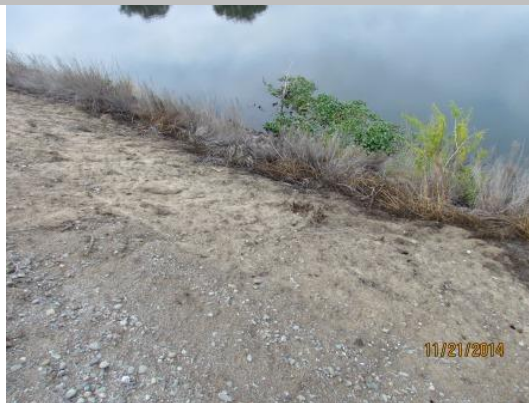
Photo 1 of 1 : SP_2016_RD2062_311_26_20160229_00030.jpg

View of the tree stump on the waterside levee slope.

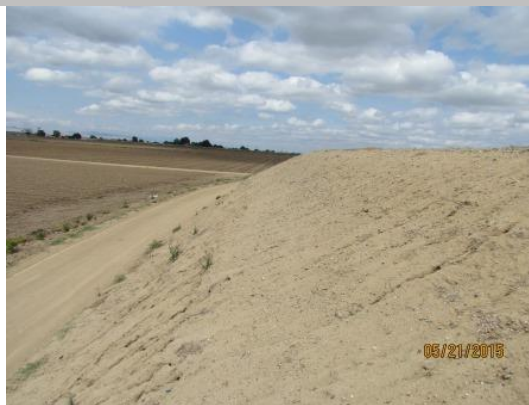
Photo 1 of 1 : SP_2016_RD2062_311_31_20160229_00032.jpg

LM Start	3.61	Rating **	M	Issue No.	31
LM End	3.66	Issue Type +	Ma	Location *	LS
Category	Earthen Levee			GPS Latitude/Longitude	
				Start	End
Item	Erosion / Bank Caving			37.816982 °	37.816541 °
				-121.342939 °	-121.342191 °
DWR ID	DWR_RD2062_03_s _ 2015_31				
Comment Code					
E2 : Schedule repair of erosion site prior to the next inspection.					
Inspector Comment					
About a 3 ft vertical cut at the levee toe into the levee prism.

View of the eroded landside levee toe.

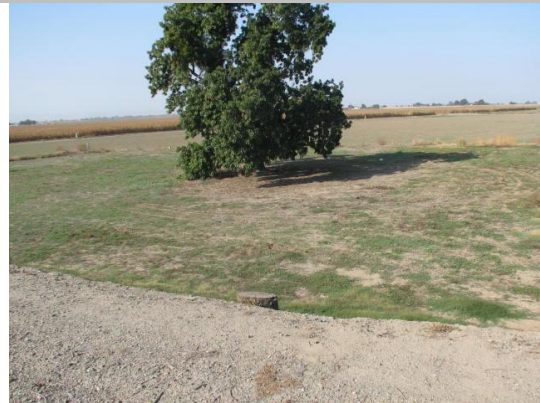
Photo 1 of 1 : SP_2016_RD2062_311_7_20160229_00012.jpg

10/21/2011 Photo taken the next day. Stump can be seen in the lower center of the photo.

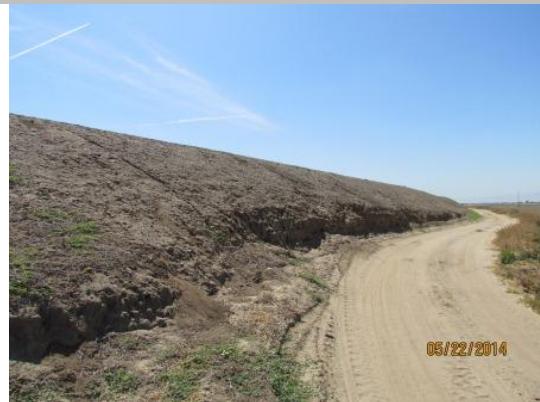
Photo 1 of 1 : SP_2016_RD2062_311_35_20160229_00034.jpg

LM Start	4.83	Rating **	M	Issue No.	35
LM End	4.91	Issue Type +	Ma	Location *	LS
Category	Earthen Levee			GPS Latitude/Longitude	
				Start	End
Item	Erosion / Bank Caving			37.812849 °	37.811682 °
				-121.336116 °	-121.336271 °
DWR ID	DWR_RD2062_03_f_2014_35				
Comment Code					
E1 : Note and monitor erosion site.					
Inspector Comment					
2 to 3 feet vertical cut possibly caused by previous floods.

View of a 2-3 feet vertical cut at the landside levee toe.

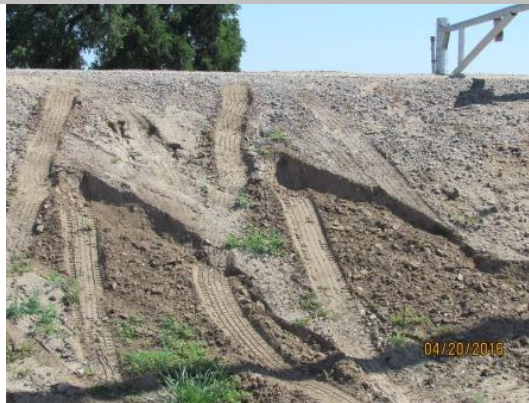
Photo 1 of 1 : SP_2016_RD2062_311_28_20160421_00050.jpg

View of the vehicle tracks on the landside levee slope.
